Mactaquac Generating Station, New Brunswick, Canada

# Stress Relief for Big Dams

## Wire Sawing Relieves Concrete Stress Caused by AAR

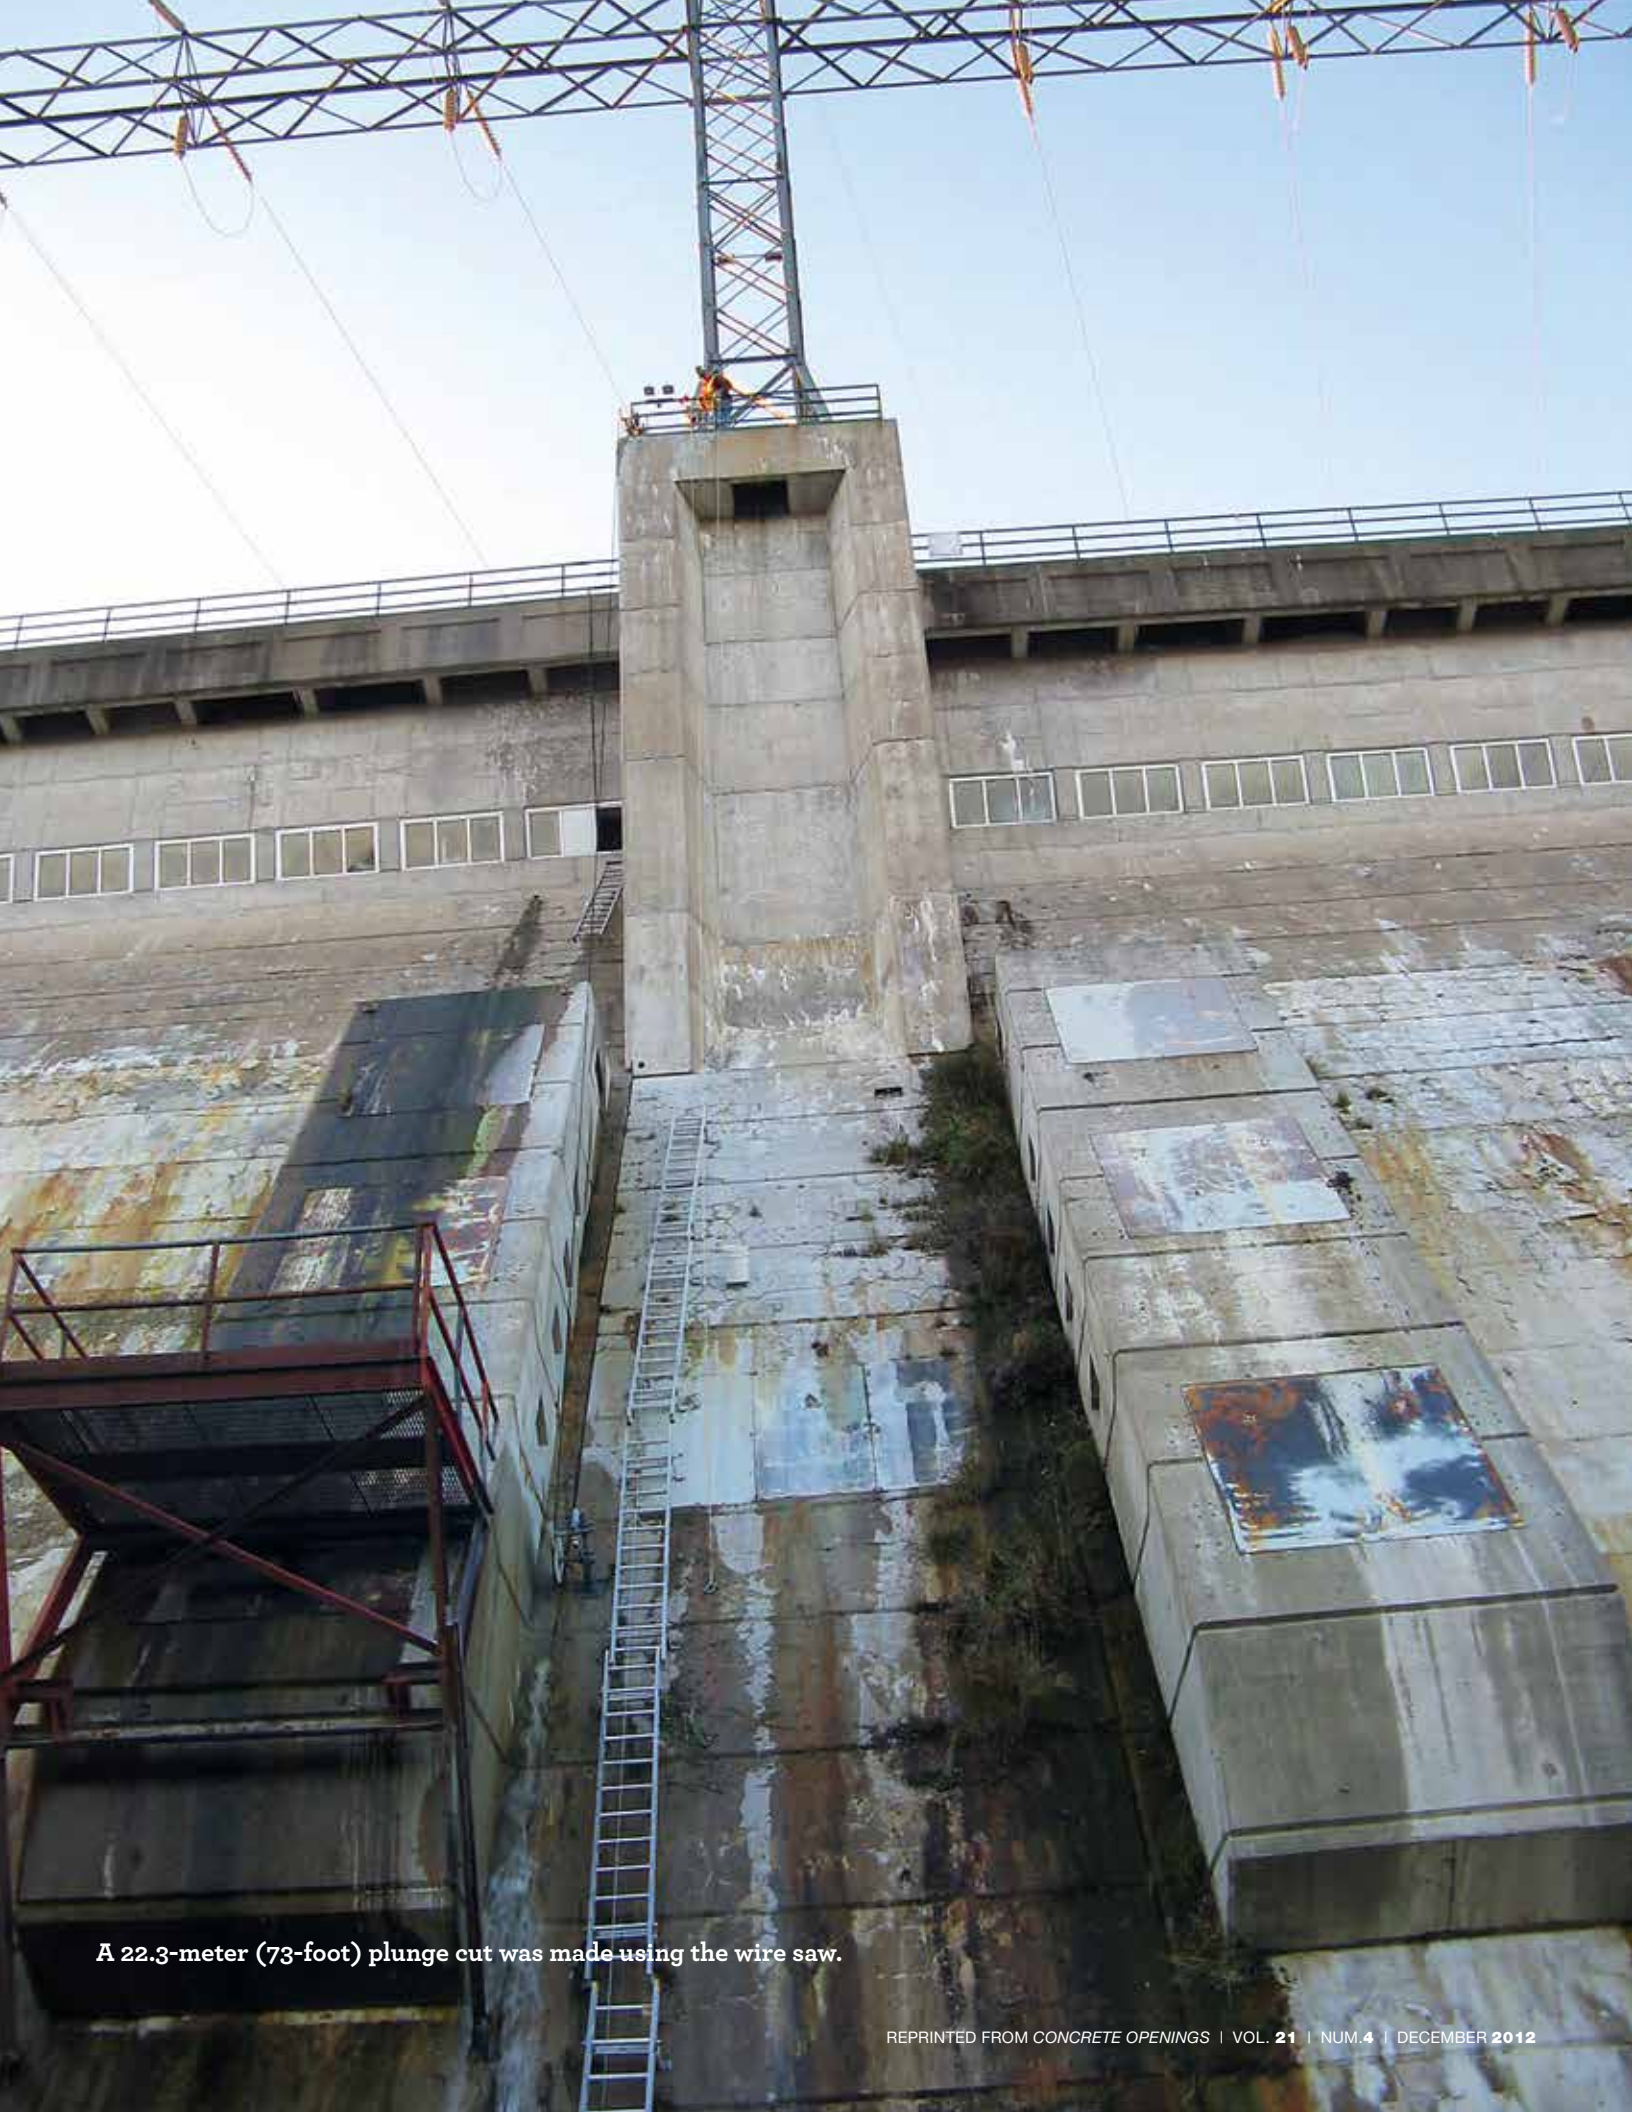
A 22.3-meter (73-foot) plunge cut was made using the wire saw.

Cutting Edge Services used a unique hydraulic-driven machine that was custom fabricated to feed 3.3-meter-long (10.8 feet) sections of aluminum tubing downward. The system is capable of plunging down to a depth of 33 meters (108.3 feet), but was only required to plunge 25 meters (82 feet) on this job.

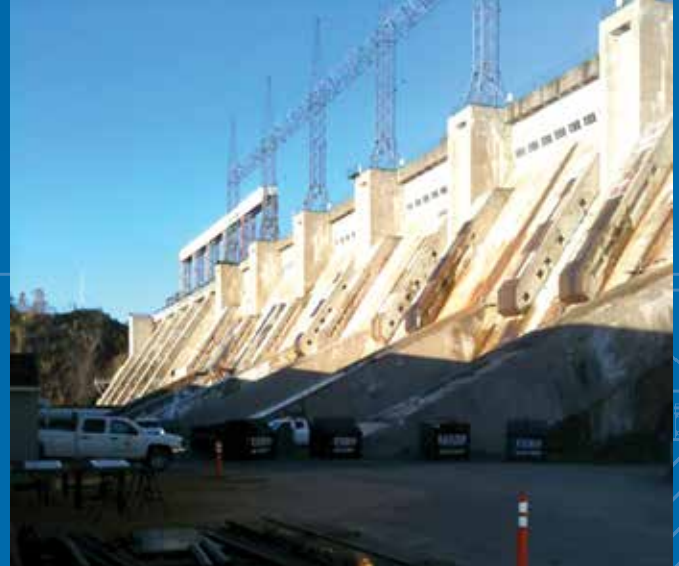
Parts of the Mactaquac Generating Station were affected by Alkali Aggregate Reaction.

In 1985, spillway gate 10, adjacent to the intake structure, was found to be obstructed. A differential displacement of the spillway end pier toward the gate opening in excess of 25.4 millimeters (1 inch) was noted. It was at this point that the end pier of the spillway was found to be cracked internally. The cause of the detrimental expansion and subsequent cracking was then identified as AAR.

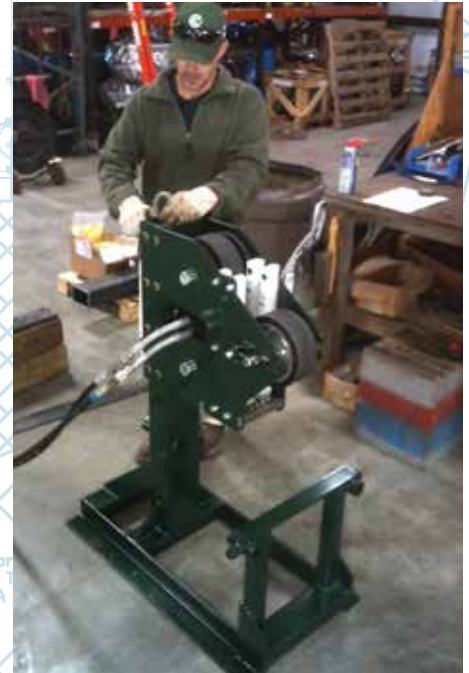
The contractor engineered a custom downhole pulley system for the work.

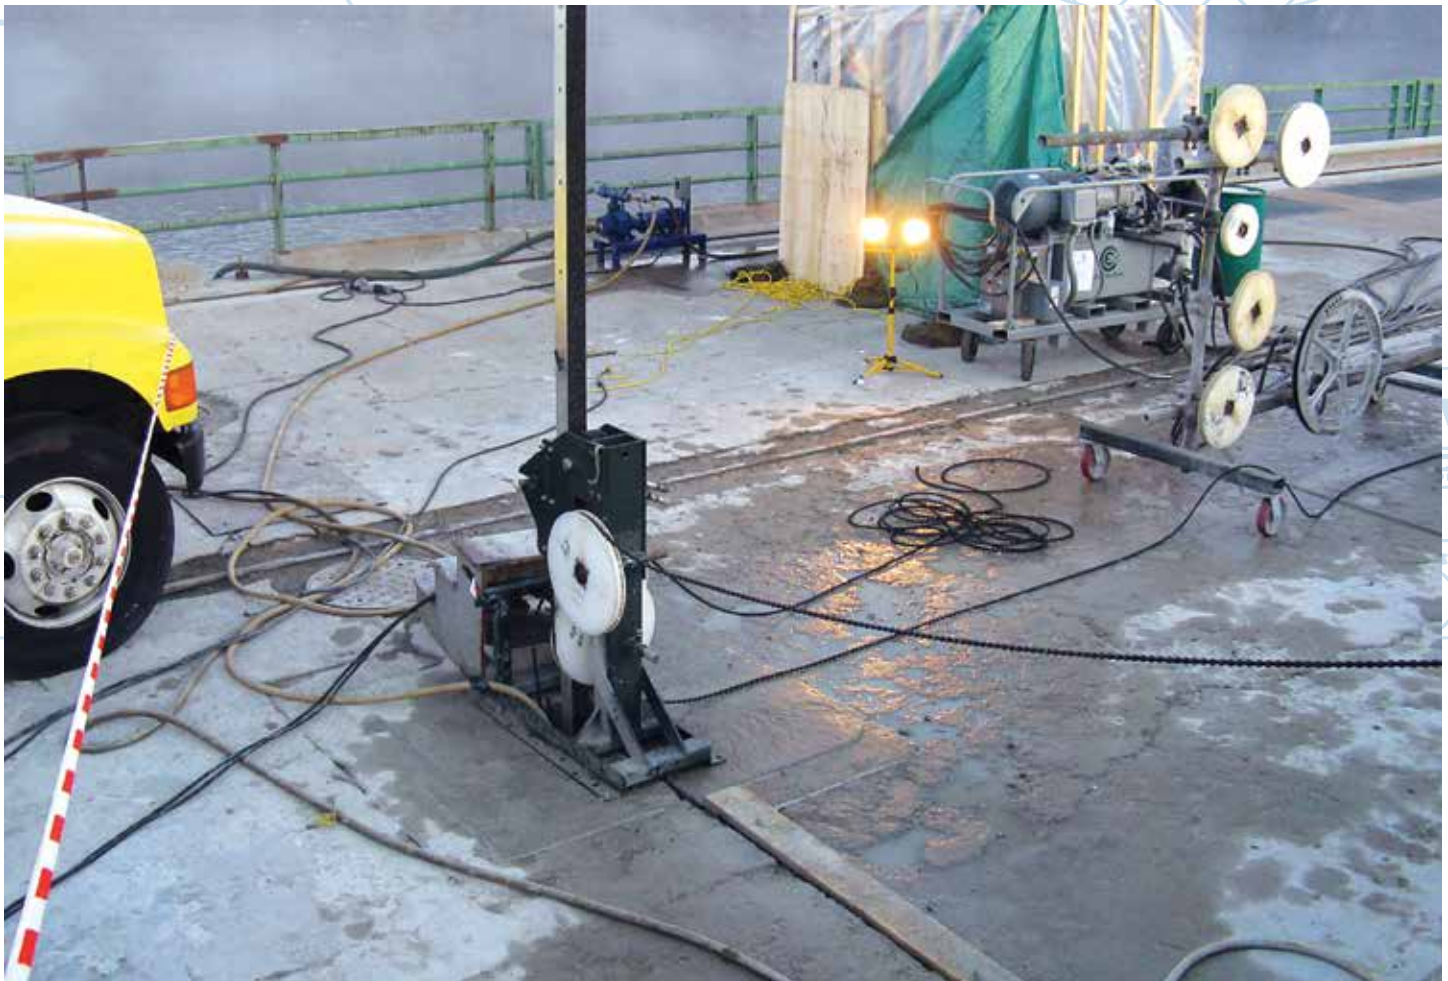
Wire sawing techniques were employed to cut and remove damaged sections of concrete.

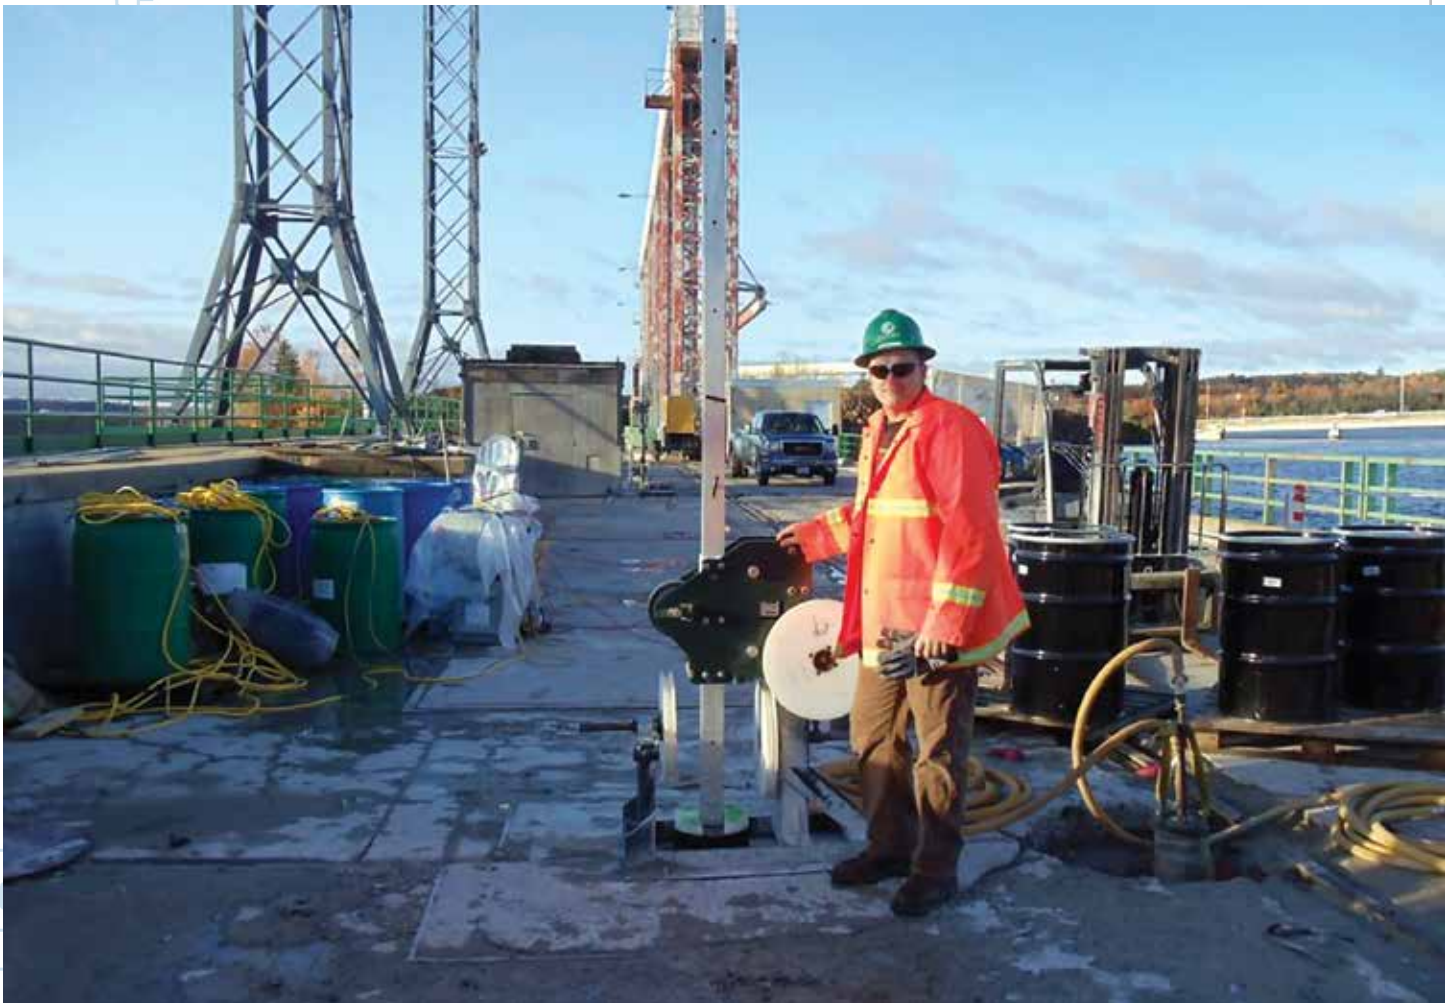
The average speed of the wire saw was 1,200 meters (3,937 feet) per minute.

the average cutting speed was around 1,200 meters per minute (3,937 feet). Pressure on the wire was relatively low to maintain wire speed and deal with concrete slivers and debris in the cut line. Gauge pressure at the power unit was in the range of 2,500-3,000 psi. Connections in the butt joints of wires were monitored and replaced at 2-4 hour intervals and cutting was performed around the clock.
